CONNECTICUT RIVER BASIN
NEWINGTON CONNECTICUT

MILL POND DAM CT 00164

INSPECTION REPORT

IDENTIFICATION NO. CT-00164
NAME OF DAM: Mill Pond Dam
TOWN: Newington
COUNTY AND STATE: Hartford County, Connecticut
STREAM: Mill Brook
DATE OF INSPECTION: December 17, 1980

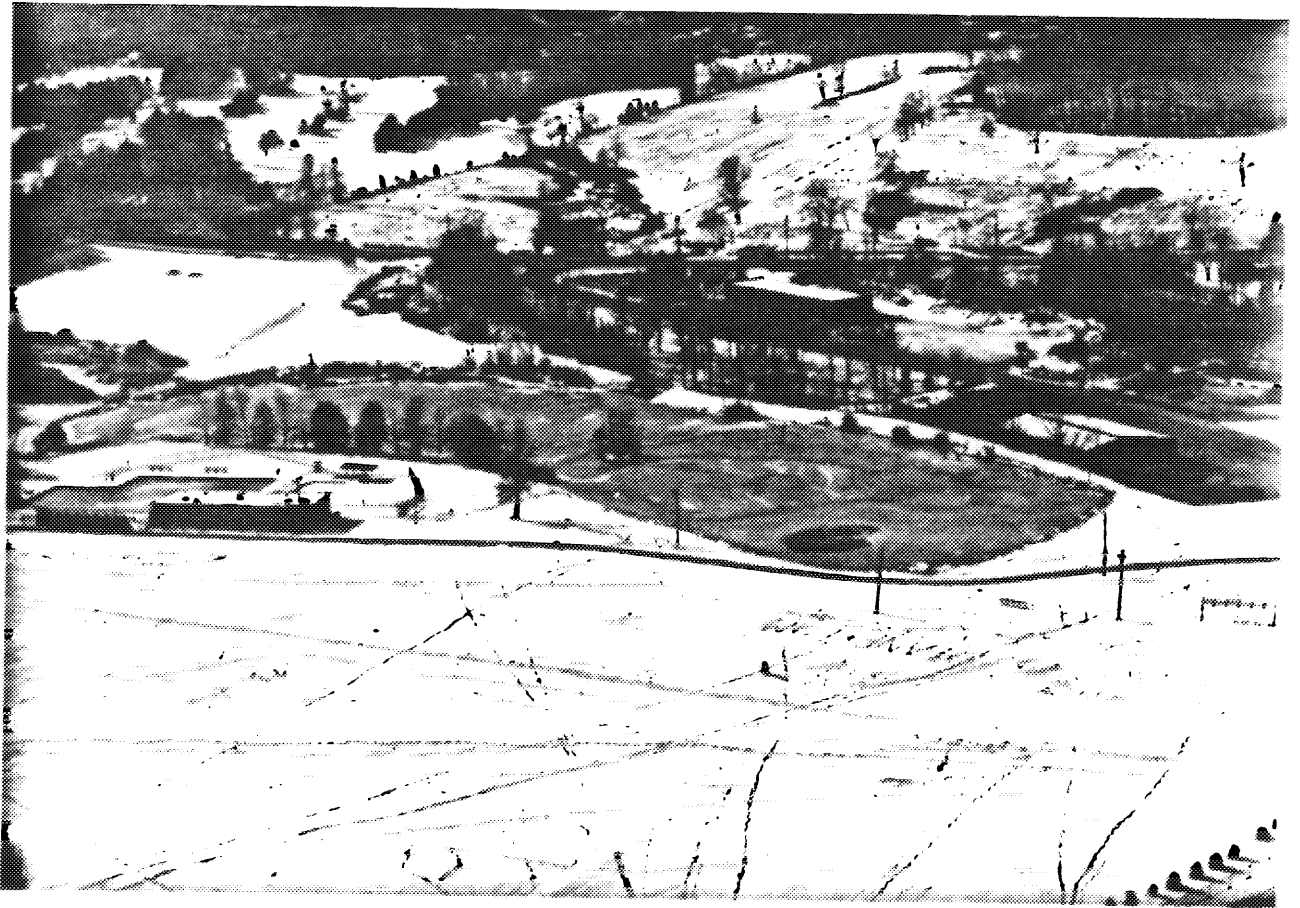
NATIONAL PROGRAM OF INSPECTION OF NON-FED. DAMS
OVERVIEW PHOTO OF DAM

1.)VIEW OF DAM LOOKING DOWNSTREAM.

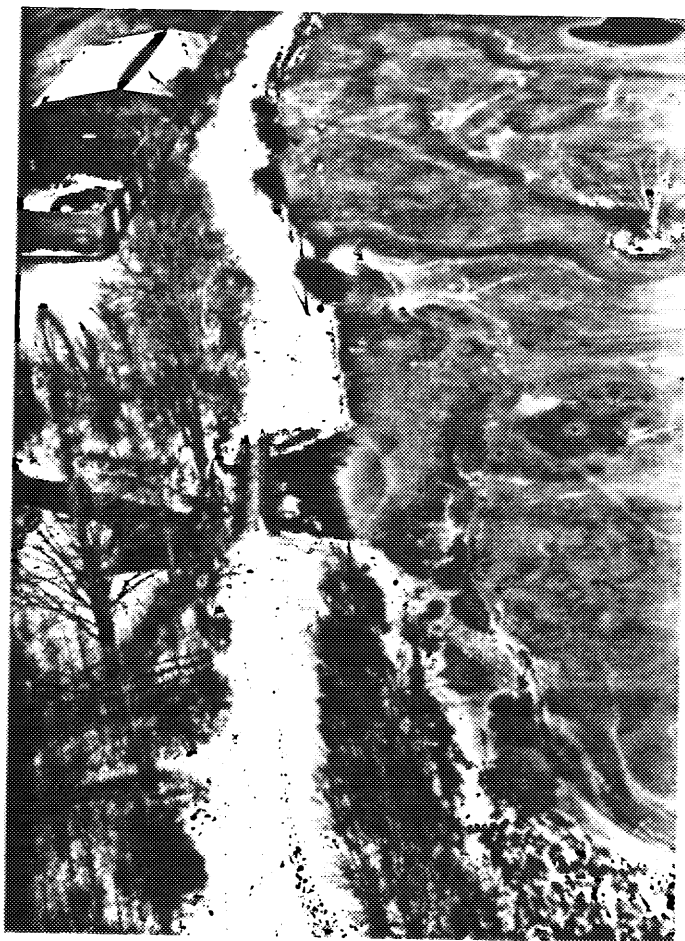
A four foot wide processed stone walk, which is in good condition, lies along the dam crest with a five foot wide wood and steel footbridge crossing the spillway. In addition, the snow covered crest, as well as the upstream slope of the embankment, appeared to be in good condition with a well maintained growth of grass. Numerous shrubs and small trees were observed along the upstream embankment slope, with a heavy growth at the south end (See Photo 1).

The downstream slope was very steep and covered with a large number of shrubs and trees, up to 18" in diameter (See Photo 1, 2 & 3). Remnants of a brick masonry wall partially retaining earthfill were observed along the downstream dam embankment as shown in Photo 4. The wall which is located on the general dam plan in Appendix B is founded on a rock base and appears to have been part of an old building. As shown in Photo 5, a four foot wide, rockfilled depression with a bottom approximately 8 ft. below the gravel path was observed on the downstream slope. The depression, which may at one time have been a sluiceway for the old waterpowered mills, showed no sign of seepage.

Photo 1 - View looking north along the
top of dam.

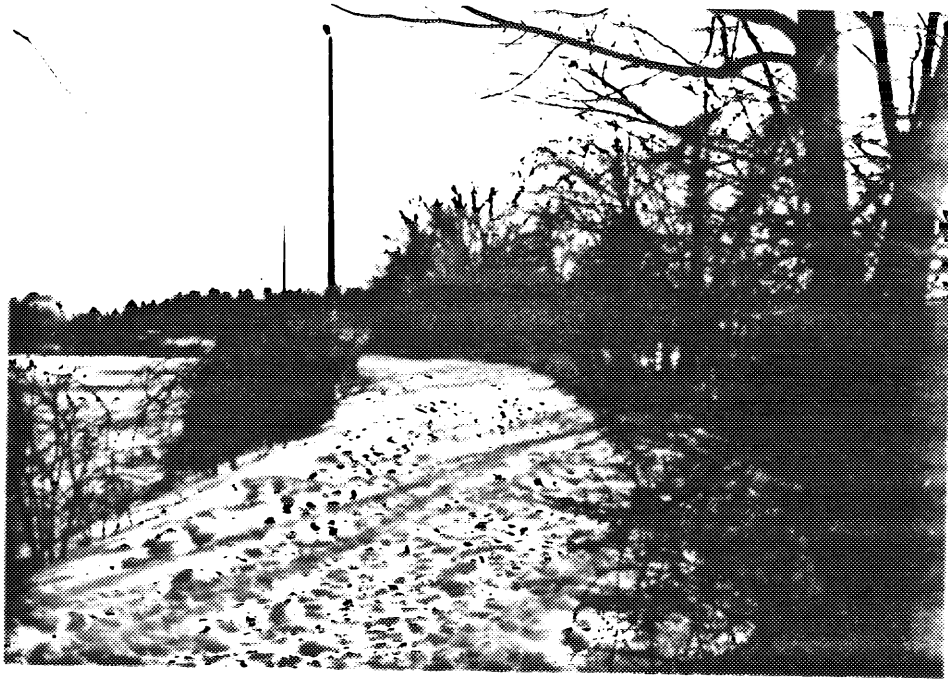
Photo 2 - View looking south along crest of dam.

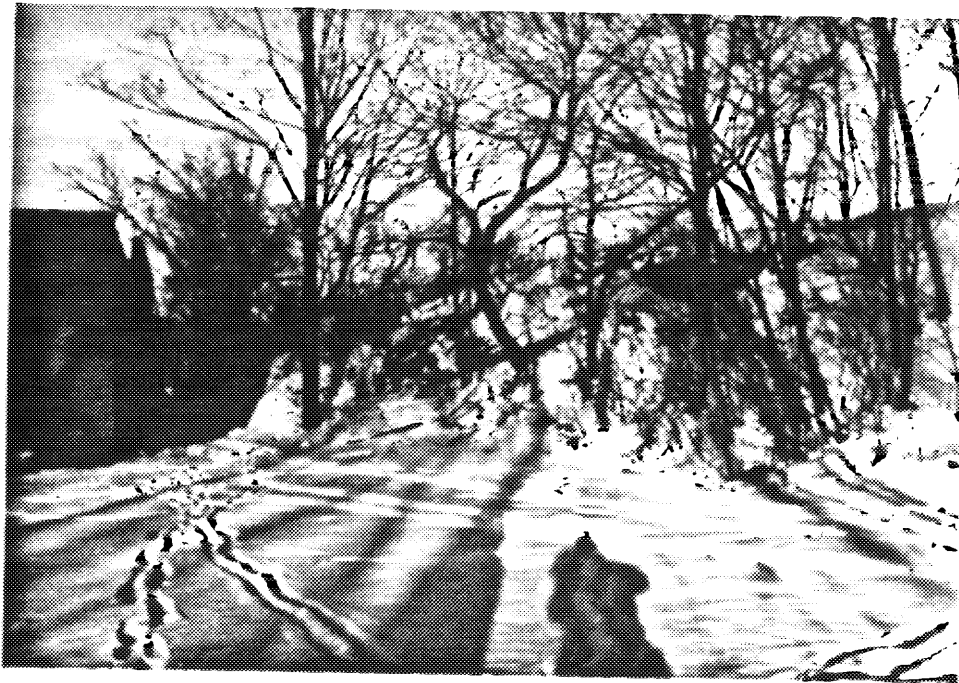
Photo 3 - View looking north along downstream side of dam showing outcrops of bedrock.

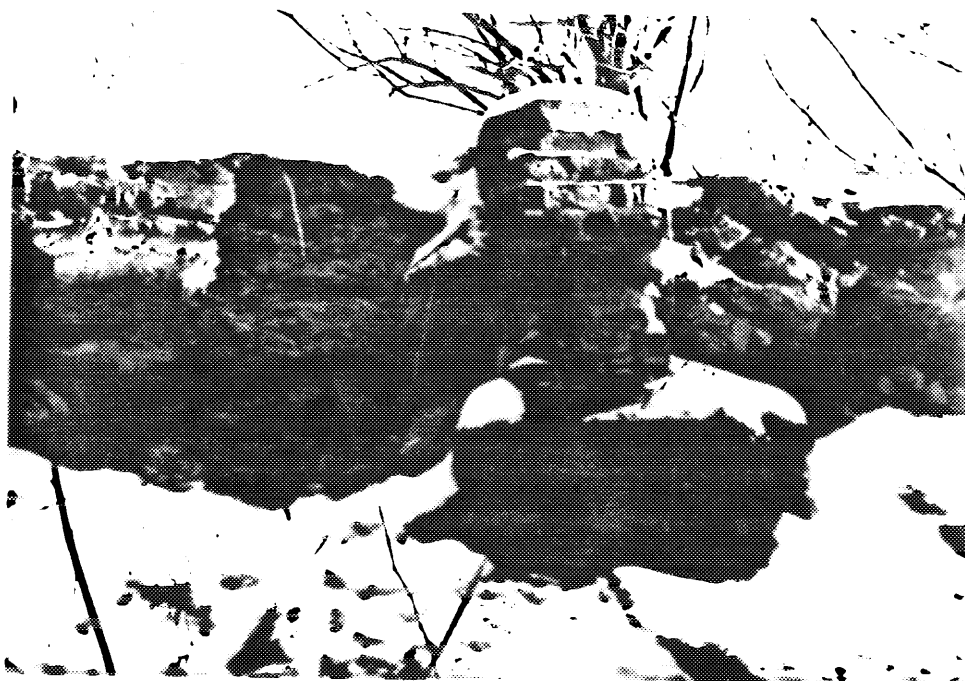
Photo 4 - Remnant of brick masonry wall on the downstream slope.

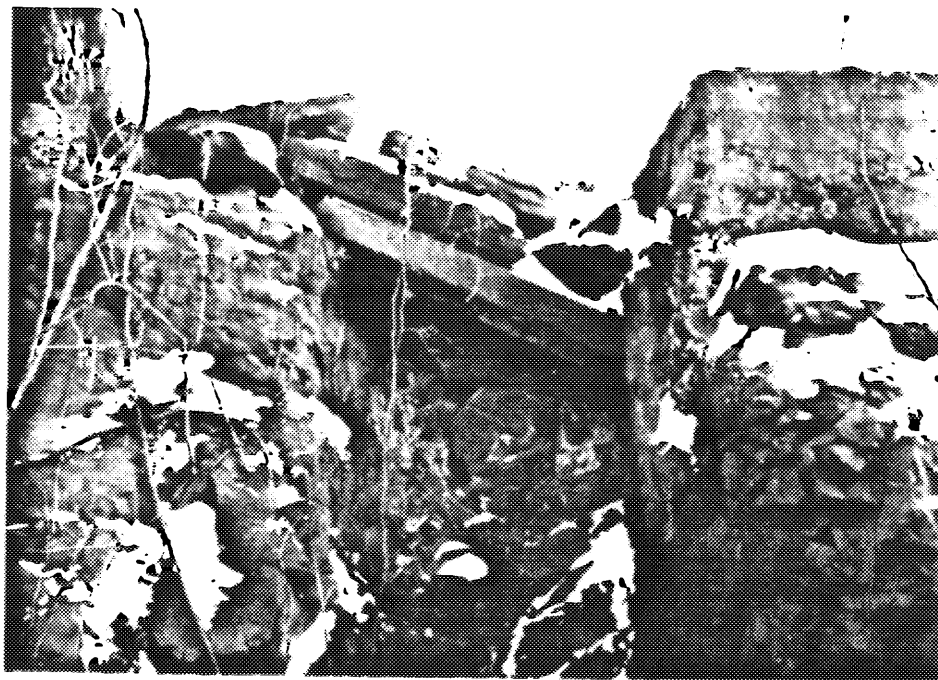
The presence of large trees and shrubs along the dam embankment does not actually affect the stability of the dam, since it is primarily a natural rock formation. Removal of these trees and shrubs would not significantly increase the dam stability, nor would it be beneficial to the appearance of Mill Pond Park; however, it is recommended that the trees and shrubs in the vicinity of the rock filled depression be removed. Their root systems could penetrate the depression area, resulting in potential seepage.

A four foot wide rock filled depression was also observed on the downstream side of the dam embankment as noted in Section 3. It could not be determined from the visual inspection whether the depression was natural or man-made; however, due to the absence of any seepage, the area is not of major concern at this time.

Photo 5 - View of rock filled depression from downstream side of dam embankment.

1. Institute a formal program of maintenance procedures and fully document it to provide accurate records for future reference.
2. Remove trees and shrubs and their root systems in the vicinity of the rock filled depression.
3. Repair eroded area along the north slope of the downstream channel.

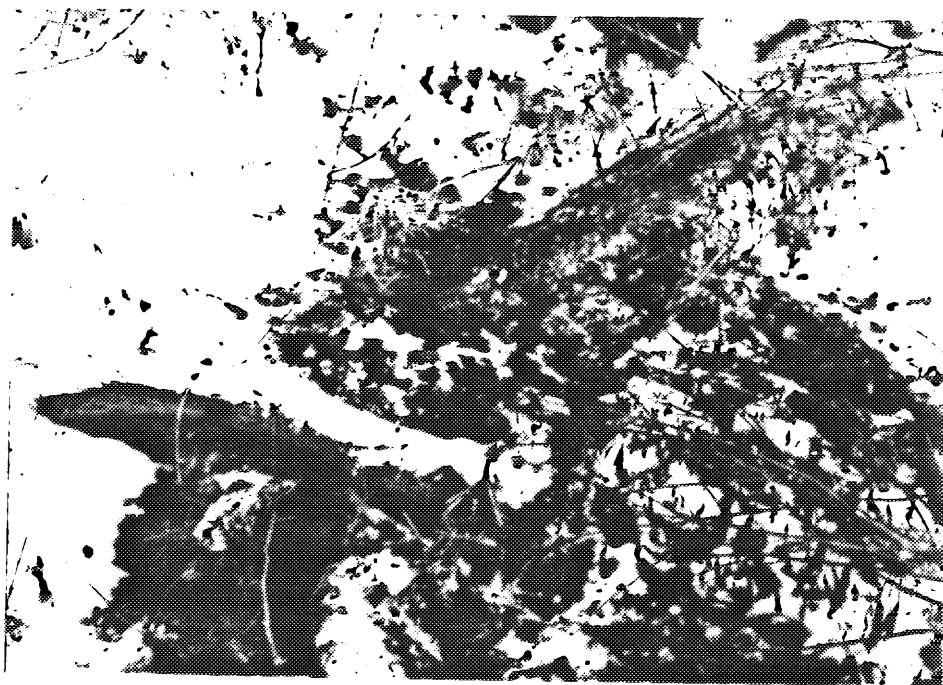
A small wet area approximately 4 ft. by 5 ft. was observed at the downstream toe of the north end of the dam embankment (See general dam plan in Appendix B). As shown in Photo 6, the exposed ground at the wet area was soft; however there was no visible seepage from the dam embankment.

The visual inspection revealed no immediate structural stability problems at this time; however, a small wet area was noticed at the downstream toe of the north end of the dam. Although there was no seepage observed, the wet area indicates that a seepage problem may be present which could possibly decrease the structural stability of the dam. The unconfirmed information from local residents suggests that this section of the dam may be earthfill and/or contain a portion of an old 48" iron intake pipe. It is quite possible that the seepage may be a direct result of either, or both, of these factors.

Photo 6 - Wet area at downstream toe of dam embankment (North End).

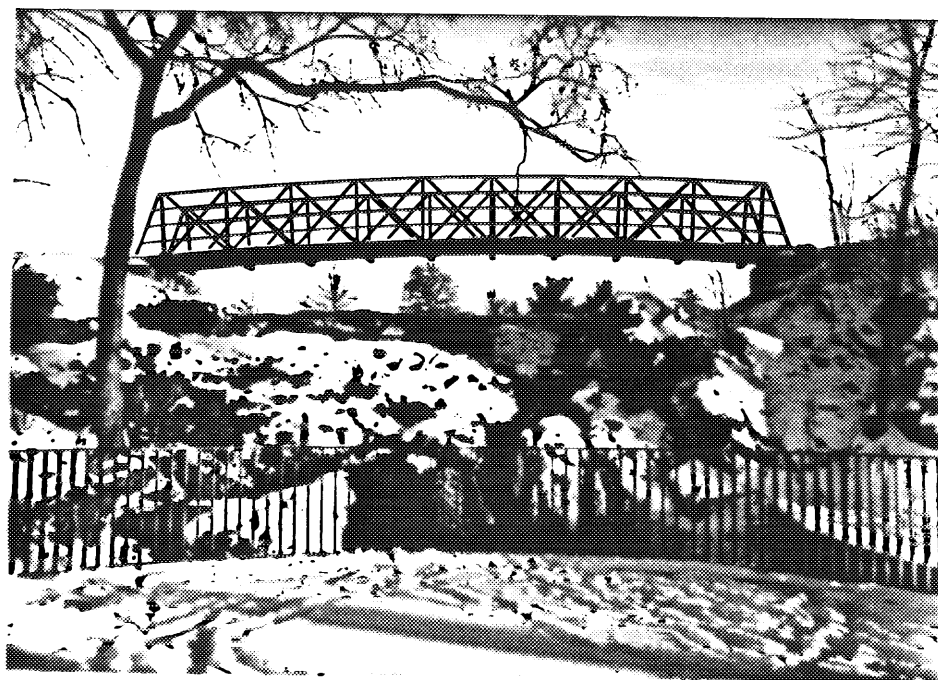
The spillway, which is an irregular natural rock formation, is in good condition with no signs of loose rock or unusual wear (See Photos 7 & 8). Extending over the spillway, the wood and steel footbridge was also in good condition. There was no evidence of any cracking or spalling of the concrete footing or abutments which can be seen in Photo 8. The wooden walkway and railings and the steel supporting substructure were well painted and appeared structurally sound.

Immediately downstream from the spillway, the rocky discharge channel was generally clean with a few trees overhanging the channel (See Photo 7).

Photo 7 - View of natural rock spillway and foot-bridge over spillway.

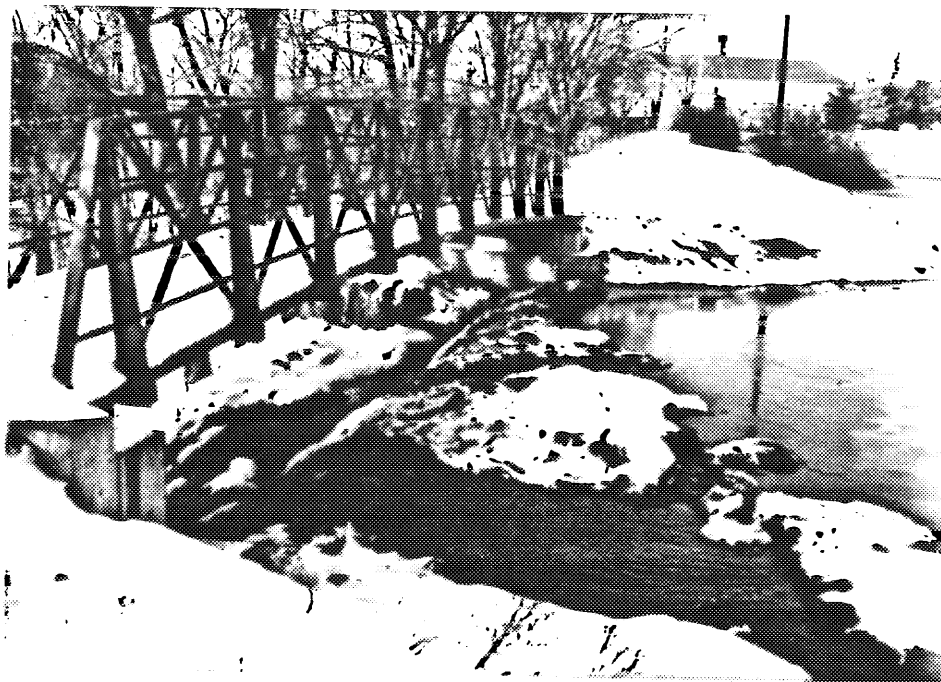
Photo 8 - Spillway Crest - Natural Rock

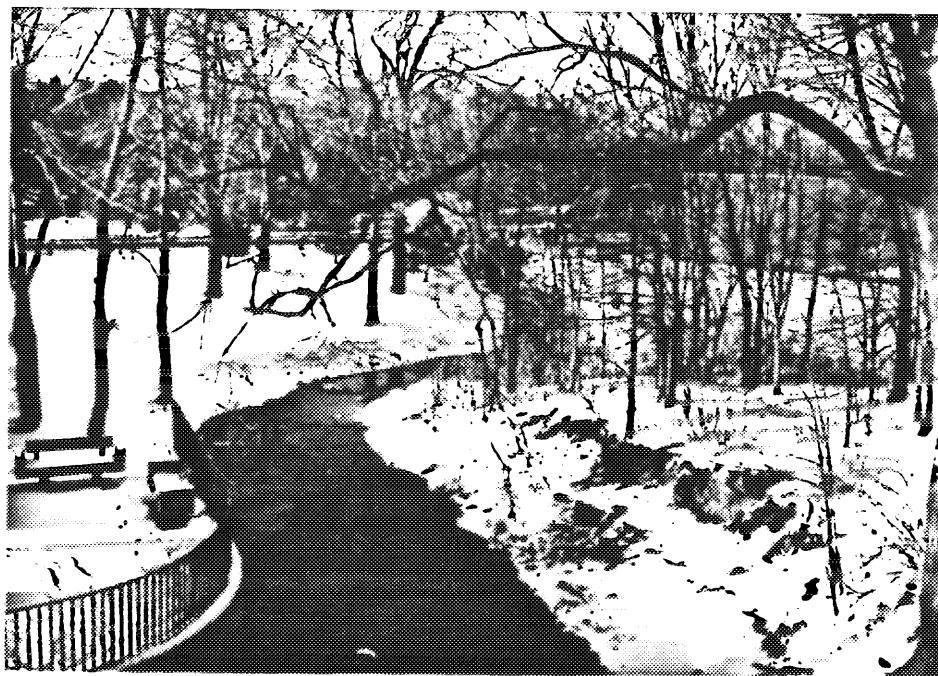
Consisting of a rocky bottom and grass lined slopes, the downstream channel (Mill Brook) is generally in good condition. As can be seen in Photo 9, moderate erosion was observed along the north bank of the channel immediately downstream from the spillway. Across the channel from the eroded area is the recently built concrete patio which is in good

condition as shown in Photos 7 and 9.

Photo 9 - Downstream Channel
